Town of Arlington Community Preservation Act Committee

Final Application for FY20 CPA funding

OLD BURYING GROUND & TOMBS AT MOUNT PLEASANT CEMETERY PRESERVATION PLAN

ARLINGTON, MASSACHUSETTS

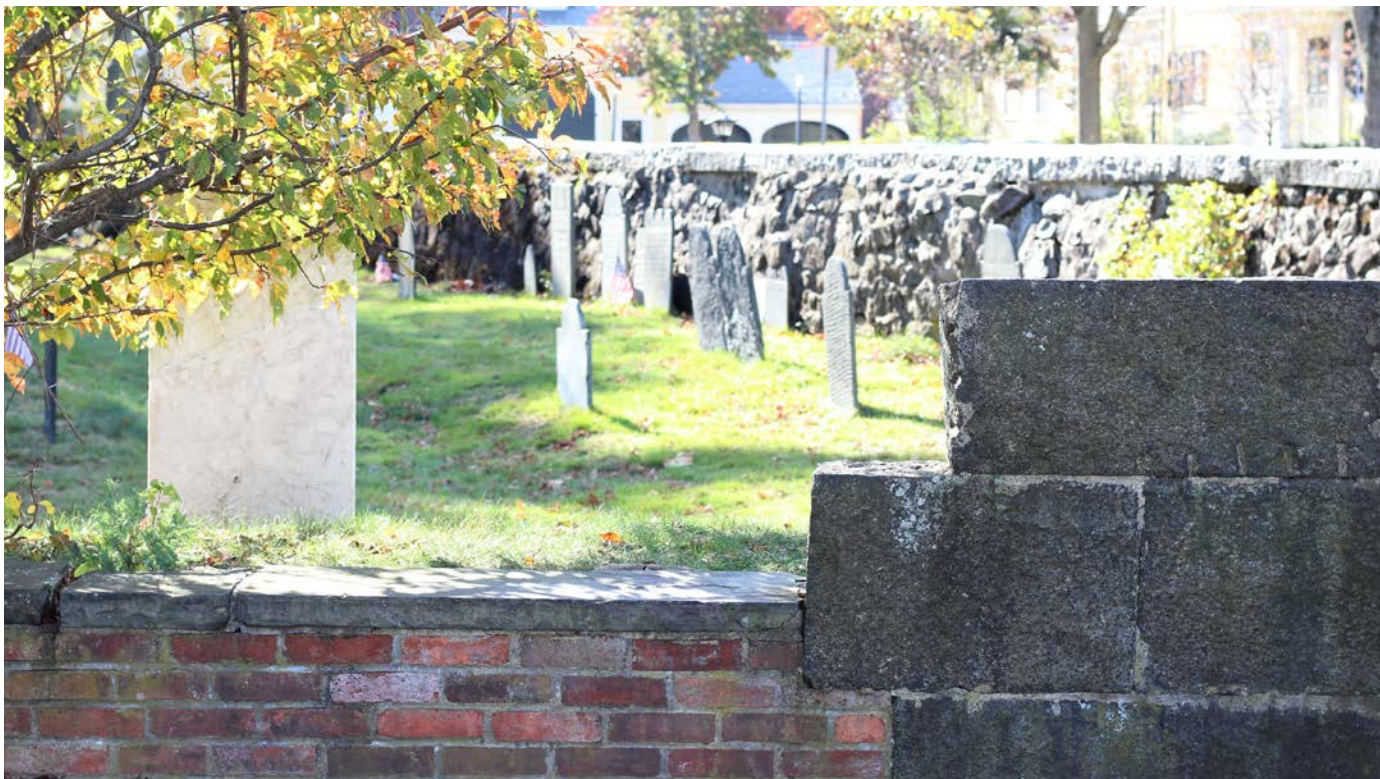
OBC Walls Vary in Their Construction and Condition; View of Brick, Granite Block and Fieldstone Walls Beyond

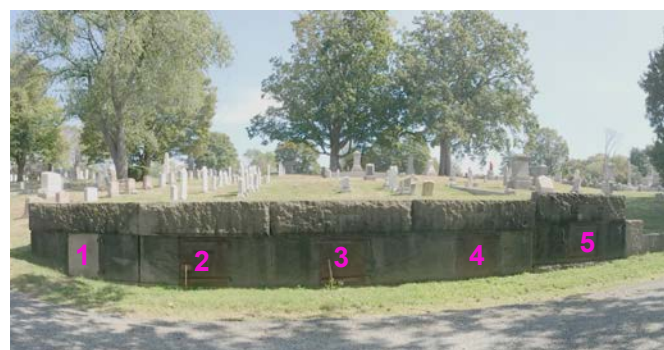
Five Mound Tombs at Mount Pleasant Cemetery

The row of five mound tombs are constructed with masonry walls with stone slab ceilings. The top of the tombs are covered with turf and soil. Brick masonry located on the west side wall is failing. There are many open joints that are missing mortar. The front stones are shifting outward. Four tomb doors are rusted and inoperable, and one tomb door is missing.

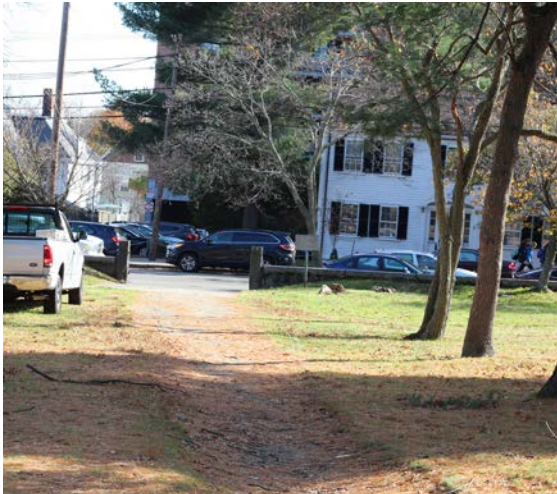
1. Pleasant Street entrance

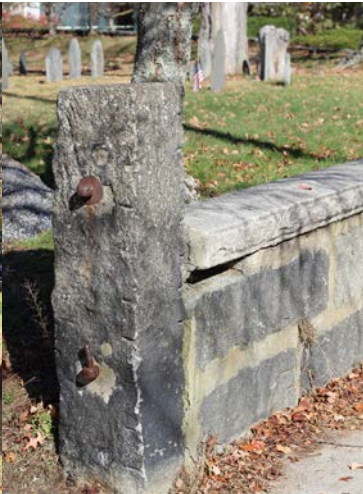
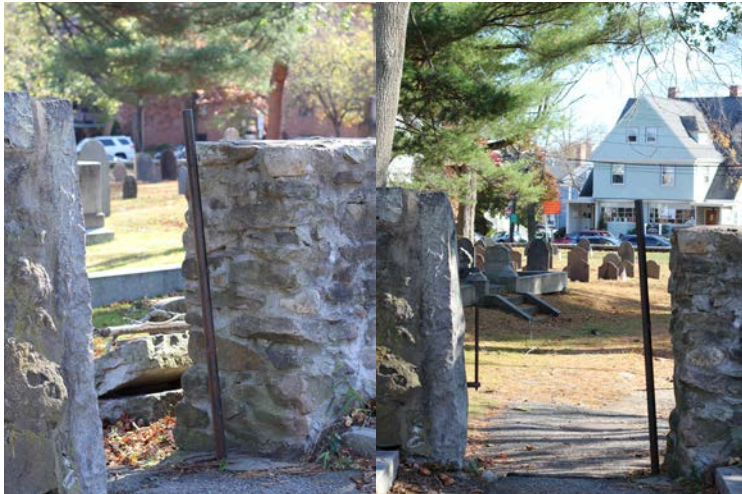
2. Peg Spengler Way entrance

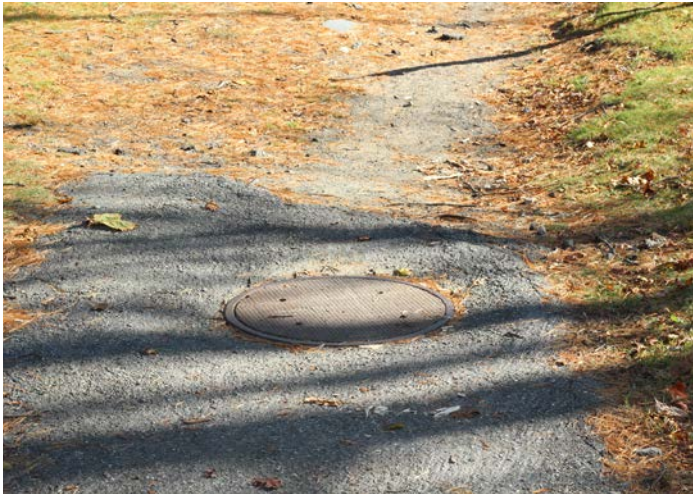
3. Bituminous path

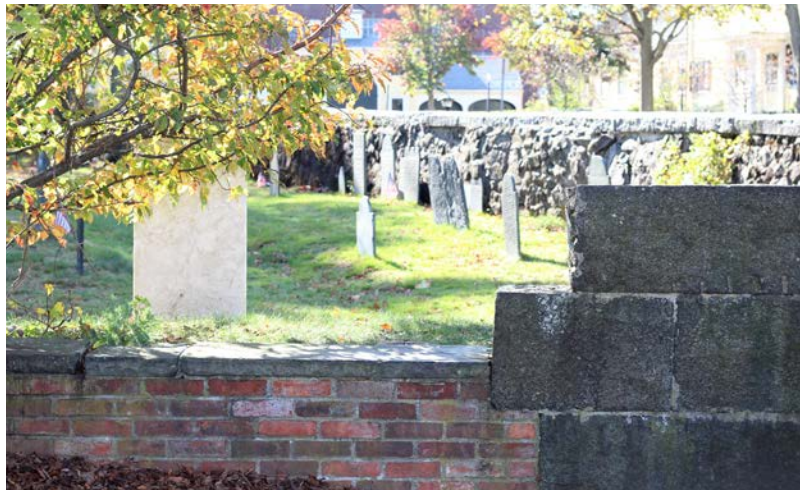
7. Northeast wall - brick

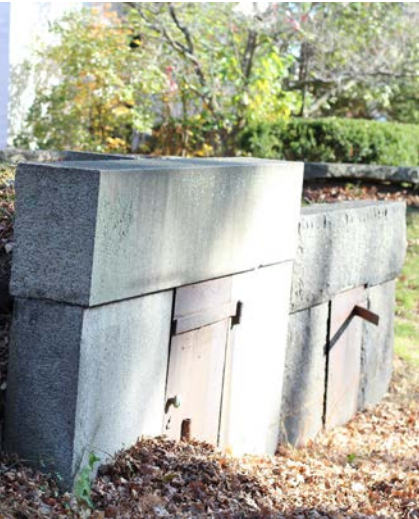
8. Interior tomb walls

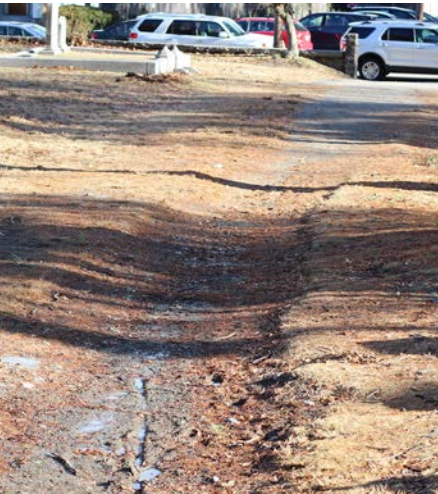
15. Low area
